## ARCHITECTURAL ASSESSMENT Curtis School (School District Offices)

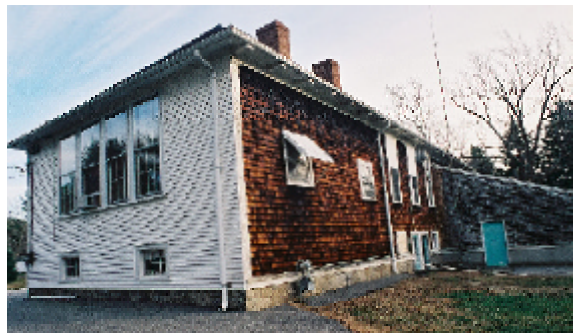
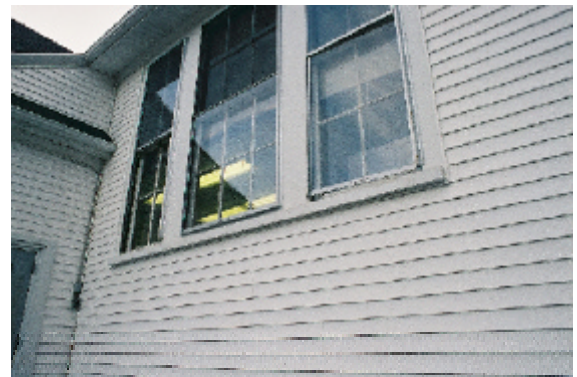
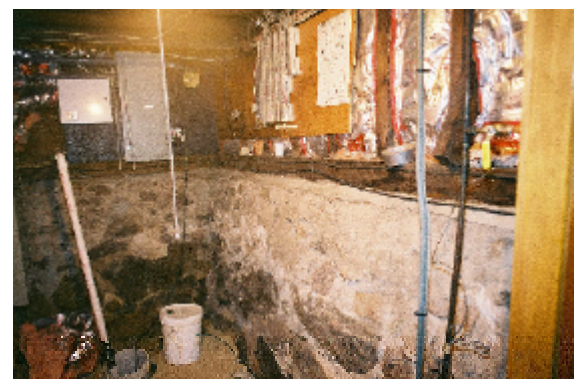
1. Asphalt shingles were noted in several locations around the chimneys to be lifting and in one particular area on the front side of the building an entire section of shingles (3' x 4') was sliding off of the roof, exposing the wood substrate to the elements. We recommend that this be addressed immediately to prevent leaks into the building and additional damage.

2. Wood shakes at the rear of the building are severely weathered and brittle and should be replaced.
3. Vinyl siding and storm windows were installed poorly. Some components missing, areas not fastened properly, inconsistent method of installation.

4. Remaining portions of original wood trim exhibit peeling paint and deteriorating wood.
5. All the wood doors around the building, including the garage overhead wood door are deteriorating at the base. These should all be replaced.

6. Concrete stairs are cracking and do not have a railing. Recommend replacement.

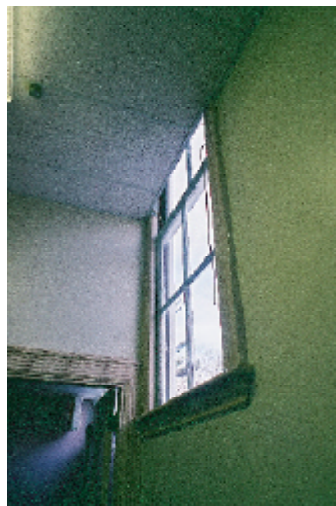
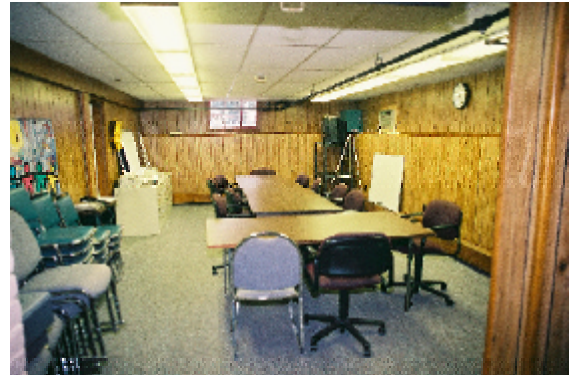
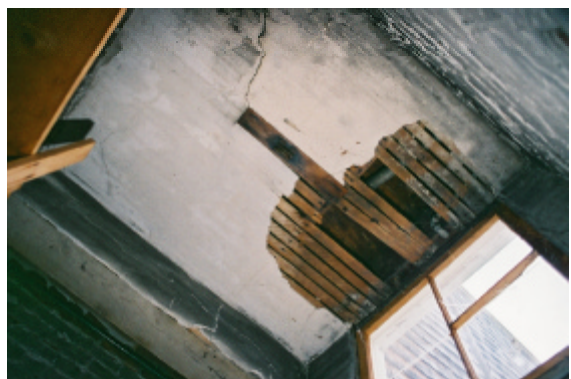
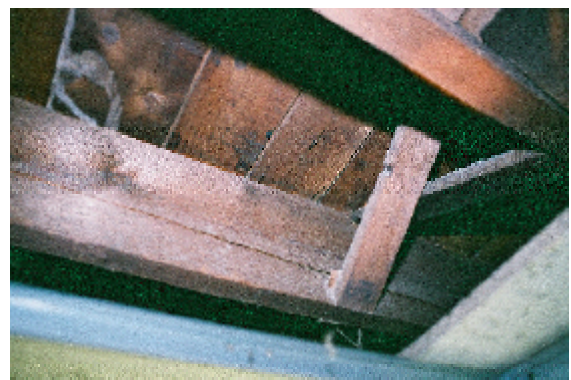
Walls are wood framed with a combination of plaster lathe and gypsum board. Original walls have wood beadboard wainscot, some new walls mostly have false/simulated wood paneling. Doors are of wood construction in various levels of quality and condition. All should be replaced.

Concrete floor in basement is cracked and very uneven.

Original ceilings are tin decorated panels, but most of these have been covered by suspended acoustical ceiling tile. The basement level has some areas where the ceiling height is 6' above finish floor.

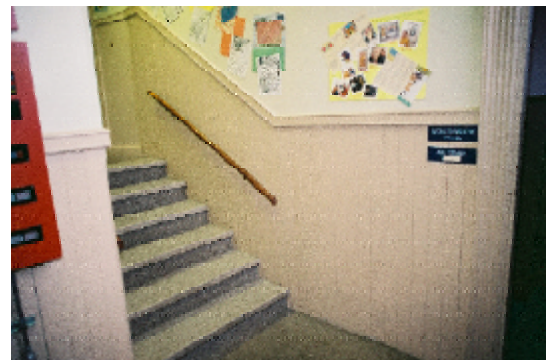
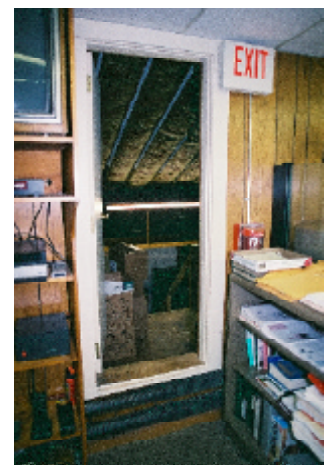
1. The entire below-grade level of the building would not be acceptable for classroom use (by current Life Safety codes) as the sill height of the windows is above the maximum allowed (3'-6").
2. Handrails (no extensions) do not comply.
3. Floor to ceiling height (head clearance) at stairs is 5 ft, well below the 7'6" minimum.
4. The basement level has some areas where the ceiling height is 6' above finish floor. This is not compliant with current code.
5. Building is entirely wood construction with no sprinkler system installed.
6. Exit corridor in basement narrows to 30" at rear exit. Not in compliance with current code.

7. Although the building's fire alarm system appears to have been recently upgraded, the egress path at the rear of the main level requires the occupant to step 1 ft up onto a threshold, over exposed fin-tube radiation, and onto a wood platform where one now must travel down non-compliant stairs, through piles of stored items and out the garage door. This path of egress is a safety concern and is not compliant with current codes.
8. Lavatory at men's toilet room is located outside of the room. This does not meet current code.
