ARCHITECTURAL ASSESSMENT

Hanover High School

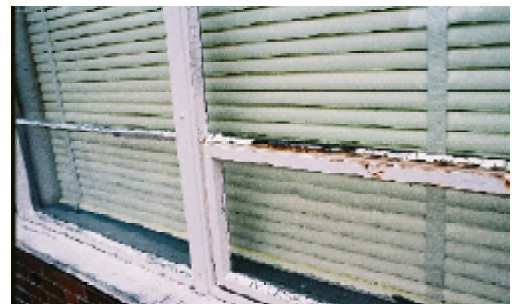
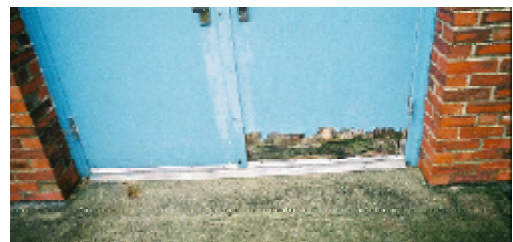
- b. Rotting wood exterior doors; some were inoperable, others are difficult to open/close. This is a life safety

concern particularly at the doors that lead out from a stairway into the courtyard.

- 1. Repair/replace/repoint masonry as needed and install control joints.
- 2. Address roof and window flashing to address cavity wall moisture infiltration.
- 3. The entire window system should be replaced with an energy efficient, thermally broken, double-glazed, insulated Low E, operable window system that takes into consideration the entire building design. Tinted or heat mirror windows may be an option to discuss to protect against excessive glare or heat-gain. Where the metal system covers a large portion of the exterior wall, additional structural steel may be required to maintain the sheer strength of the wall. Glass block should be replaced with insulated translucent panels (Kalwall-type).
- 4. Replace all exterior doors and hardware (except for doors most recently installed).

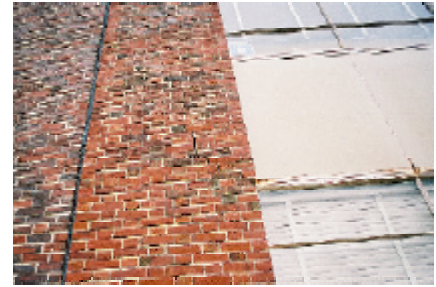
- ✍ deteriorating and discolored brick throughout,
- ✍ vertical cracks in the brick in several locations (appears to be due to lack of control joints),
- ✍ horizontal shift of brick at joint (appears to be due to lack of control joint)
- ✍ evidence of water/moisture getting behind the brick areas mostly below window sills,
- ✍ mortar in need of repointing in certain areas,
- ✍ spalling noted in the precast concrete.
- ✍ No weep holes visible.

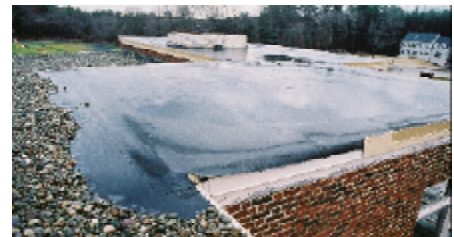
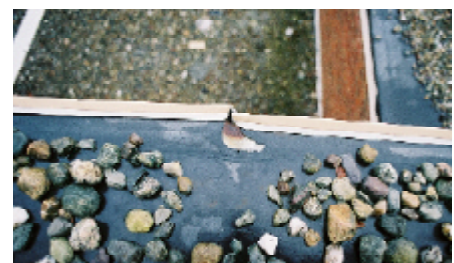
- a. Workmanship over most of the roof was noted to be very poor, particularly at the perimeter fascia. The membrane has not been fastened or sealed properly, gaps and cracks at seams and flashing areas noted. Edge seaming tape was not installed. Metal fascia and edge metal had blown off in areas all around the building perimeter/edge; one location had a 40 foot long piece missing. Deficient workmanship appears to be the primary concern on this roof. Leaks were reported at a number of locations.

- b. The ballasted roofing system for the gym roof is inappropriate for the condition; the slope is too steep for a ballasted roof system. In addition, the workmanship is

very poor. Holes and gaps in the membrane were noted at several locations, some as large as 12" long (at rooftop unit). The membrane was sparsely ballasted with stone and what appeared to be old stone walkway pads (12" x 18"). Leaks are inevitable with the roof in this condition. Leaks were reported at the Gym.

5. Replace entire roof system and fascia, except for recently installed fully adhered membrane system. Utilize tapered insulation. Install additional roof drains.
6. Replace stage smoke vents.

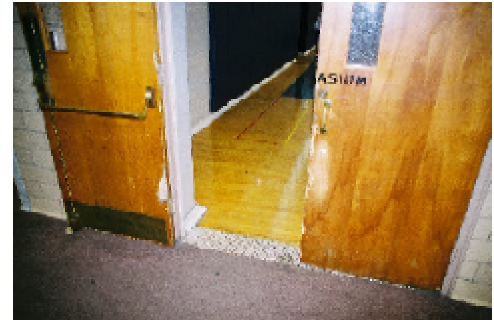
1. Interior doors are in very poor condition; heavily gouged and damaged. Hardware requires replacement due to handicap accessibility. Some doors do not meet minimum width for HC. Recommend that all doors be replaced.

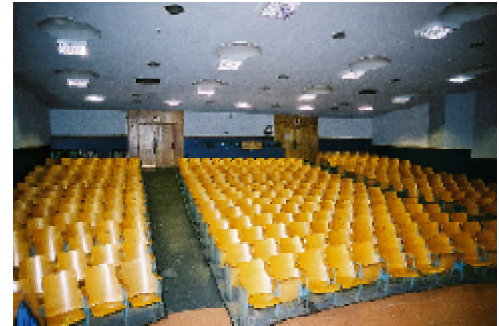
- ⌘ Do not have accessible seating, nor are they dispersed around the room.
- ⌘ Ramp is too long (42') without a landing (30' is max permitted)
- ⌘ Slope of floor steep and changes as one proceeds to the front.
- ⌘ Do not have 5' landing space at top of ramp, adjacent to doors

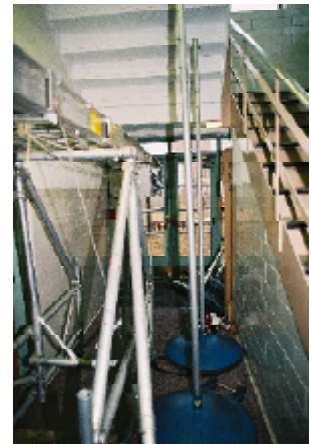
1. Stairway exits were blocked with stored items and with a hardware lock-down bar. This presents a serious life-safety concern, as these exits are required emergency exits for occupants from the 2nd floor. All doors into the courtyard were locked.
