## **ARCHITECTURAL ASSESSMENT**

### **Salmond School**

Originally constructed in 1931, the building has not had any additions and very few upgrades and interior modifications. The building is approximately 13,500 sf in area. The building currently does not serve as a school but is being used as a temporary home for the public library. As such, some educational use issues could not be addressed during this assessment.

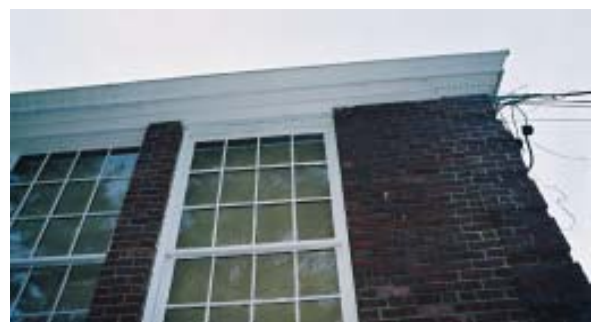
1. The brick appeared to be in generally good condition considering the age. Some locations around the building exhibited deterioration of the joints, mold and mildew. Minor brick repair, re-pointing and cleaning is recommended to prevent further deterioration.

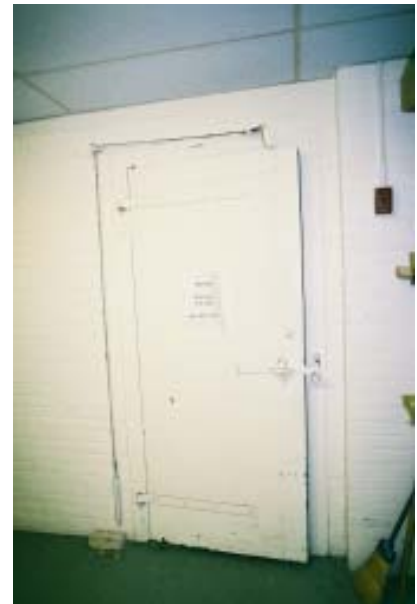
1. The entire below-grade level of the school would not be acceptable for classroom use (by current Life Safety codes) as the sill height of the windows is at least 2 feet above the maximum allowed (3'-6").
2. Guardrails at 34-1/2" (42" req'd) and handrails (no extensions) do not comply.
3. Doors to stairs are not fire rated.
4. Stair door does not open in the direction of egress.
5. Stair doors are being held open with wood wedges.

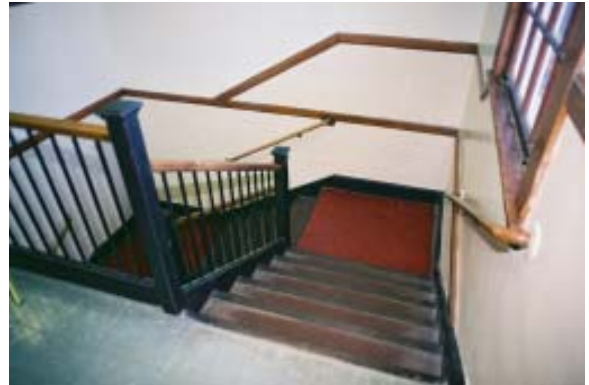
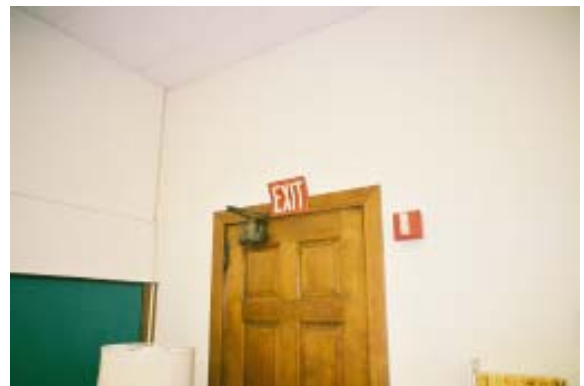
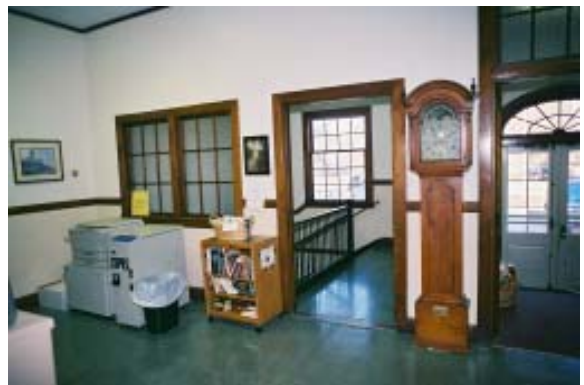
6. Building is almost all wood floor framing with no sprinkler system installed.
7. Boiler room door is old metal fire door, does not meet current code. In addition, it is not possible to close the door. Although there is a sign on the door for staff only, anyone could enter this room easily as the door is slightly ajar. This is a safety concern.
8. Although paper or metal (non-lit) exit signs were noted at some interior doors, the main exterior exit doors from the building did have proper emergency hardware on hollow metal doors and LCD exit lights.
