## ARCHITECTURAL ASSESSMENT Sylvester Elementary School

Originally constructed in 1927 with an addition in 1960, the building has an area of approximately 33,210 sf. and currently houses 235 students. General facility comments are as follows:

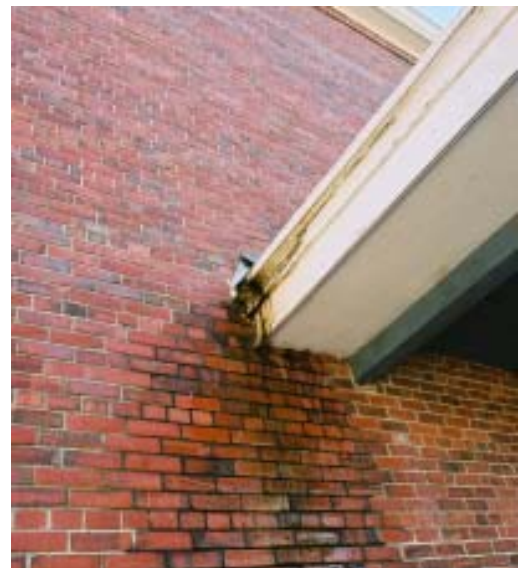
- a. The deteriorating single-pane wood windows (source of extreme heat loss). Chipping and peeling paint is most likely lead-containing paint and should be removed. Recommend full replacement.
- b. Concrete steps are in poor condition; appear to have been repaired a number of times. Recommend full replacement with accessible ramp.
- c. Deteriorated and discolored brick on the exterior of cafeteria due to years of ivy growth. Some brick cleaning and repointing is recommended.
- d. Rusted and failing steel lintels at cafeteria windows. Excessive water infiltrating the steel over time has caused the steel to expand and corrode. Lintels

should be replaced while the reason for the water/moisture infiltration should be investigated and addressed.

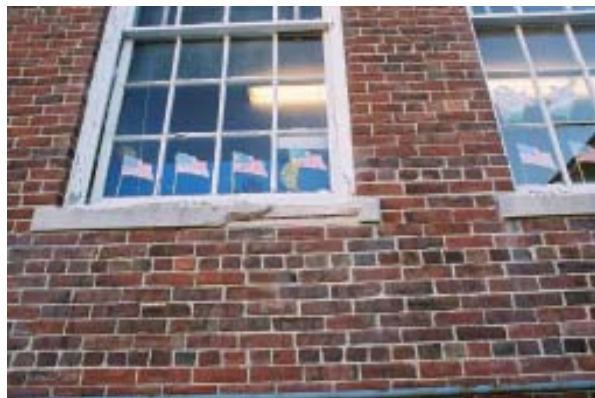
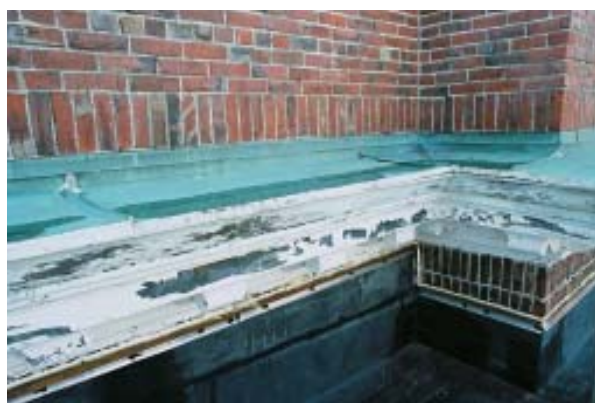
- e. Precast concrete sills at a few locations have spalled exposing re-bar. Recommend replacement.
- f. Wood cornice is deteriorating and paint is peeling extensively. Recommend restoration.
- g. Northside portico drains water against the building and has created a deteriorating effect on the brick. This should be remedied before further deterioration occurs.

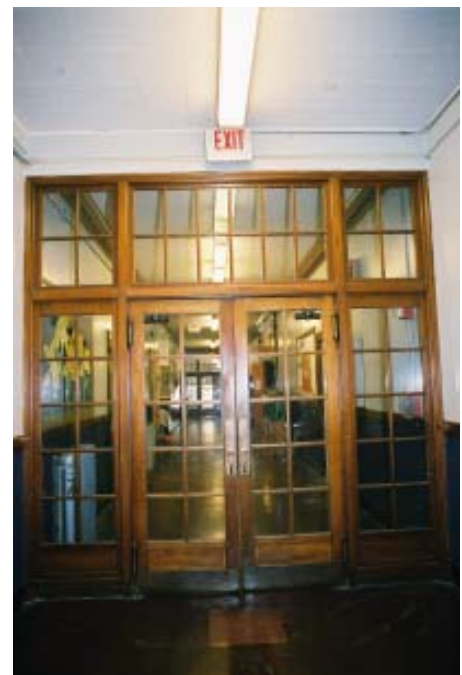
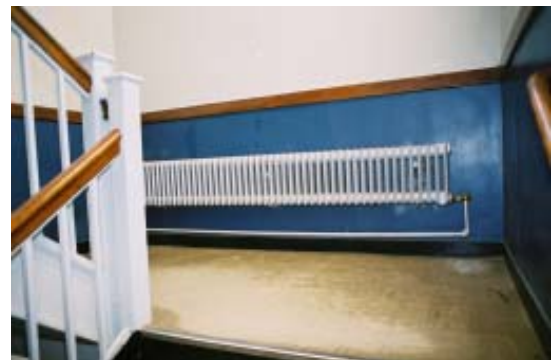
1. The entire below-grade level of the school would not be acceptable for classroom use (by current Life Safety codes) as the sill height of the windows (approximately 5'-3" above finish floor) is almost 2 feet above the maximum allowed (3'-6").
2. The school does not meet current building code for a number of reasons. Below are a few items to note that would need to be addressed during any major renovation/addition project. See also the code analysis sheet at the beginning of the feasibility study for more information.
  - a. The first floor framing other than the corridors and main entry are wood framed. This is not permitted in the current code as these should have a 1-hour fire rating.
  - b. The auditorium, cafeteria, and library do not have the required 2-hour fire ratings to meet current code.
2. Stair guardrails and handrails do not meet current life safety code requirements.

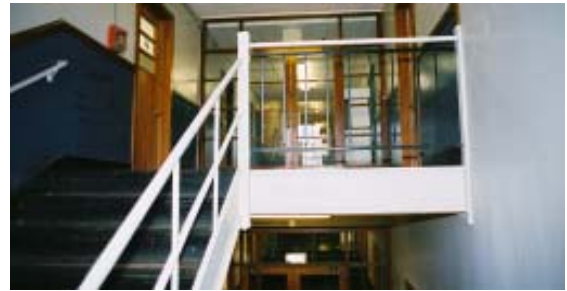
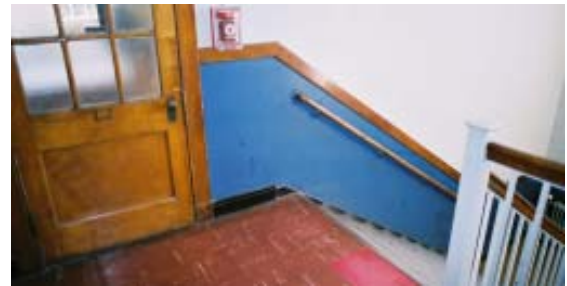
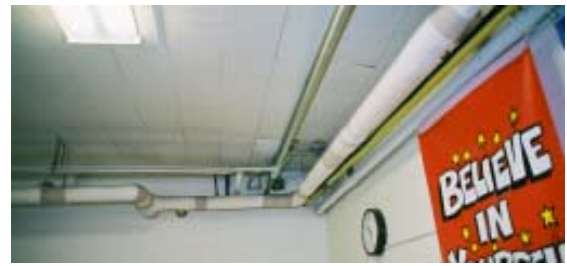
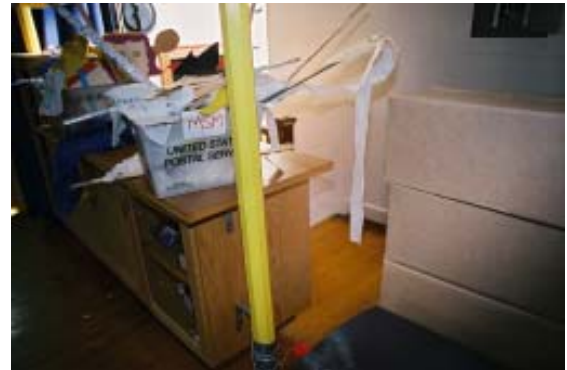
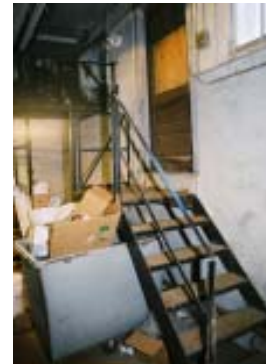
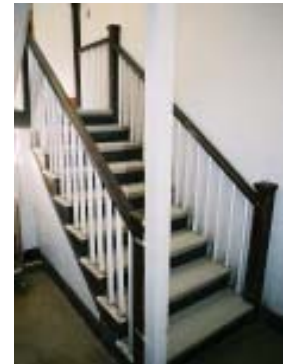
3. Plaster and paint in some areas are chipping off of the wall. Plaster has been tested positive for asbestos. Paint is highly likely to contain lead.

4. The original iron steam radiators pose a serious health and safety concern for potential burns, particularly ones located in stairs and corridors.
5. The stairs to the side of the stage and kitchen are constructed of wood, are very narrow (34-1/2" wide) and do not meet code in any respect. The exterior door from those stairs is not equipped with emergency hardware. Although not required for the auditorium, this exit is a required means of egress for the cafeteria. This is a safety concern.

6. It is important to note that the building inspector has given a certificate of occupancy to the school except for the cafeteria. This is due, we are told, due to the glue-on 12"x 12" ceiling tiles that fall from the ceiling on a regular basis. One tile fell and injured a child. There is one location in the cafeteria, adjacent to the fan room and boiler room where a portion of the ceiling is sloping down. It was not possible, at the time of visit, to determine the cause of the sloping ceiling or falling tile. But we do know that portions of the Auditorium wood floor have buckled due to excessive moisture from the steam boiler that the school used prior to its replacement in 1960. We also know that the kitchen, cafeteria and dishwashing areas have very poor or no ventilation system and that the ceiling must receive a large amount of moisture. Further investigation is recommended to address this issue.

7. There is no clear delineation for parking and bus loop. This results in a safety concern for children and pedestrians on site.
8. Problems with the electrical wiring has been reported. Some wiring has been re-done, but majority require full evaluation.

9. Items are stored under the stage; is not sprinklered.

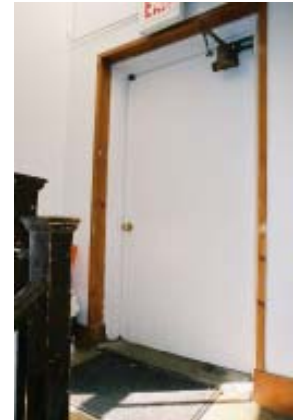
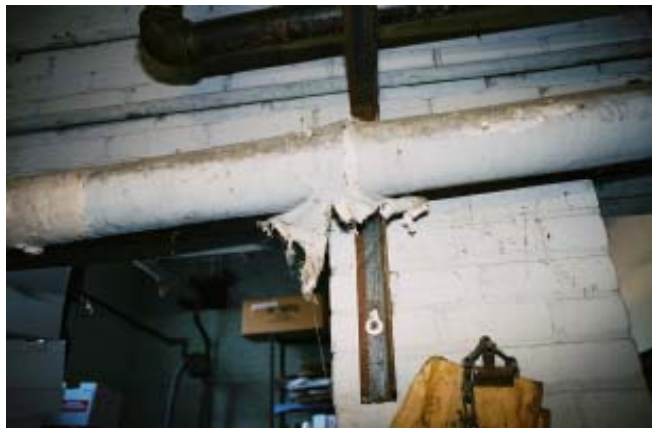
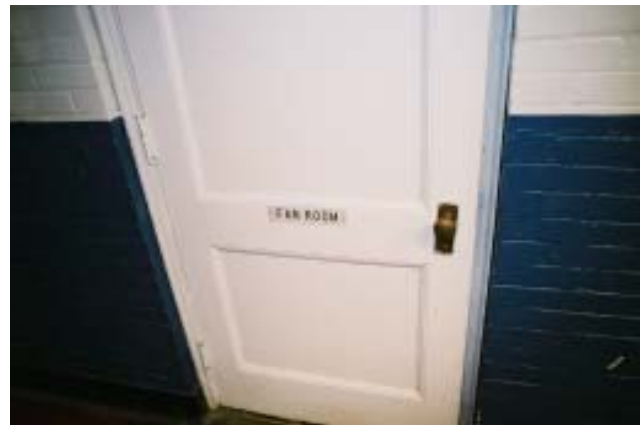
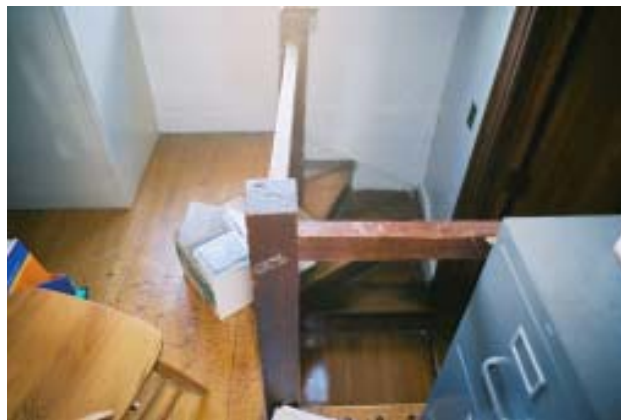
10. Corridor, stair, gym and cafeteria doors are not smoke or fire rated: are not labeled, do not have latch, no panic devices, are held open with wood wedges.
11. Classroom doors open into stairwell. This does not meet current code.
12. Boiler room door has no sign, is not locked, and is not fire rated. One door exiting from this room does not have proper exit sign. Exit doors have deteriorated/broken and are difficult to open/close. This is a safety concern.
13. Men's room in basement has a horrible sewer gas smell, possibly from floor drain.
14. Stage does not have fire curtain.
15. Building is almost all wood floor framing with no sprinkler system installed.
