## ARCHITECTURAL ASSESSMENT Curtis School (School District Offices)

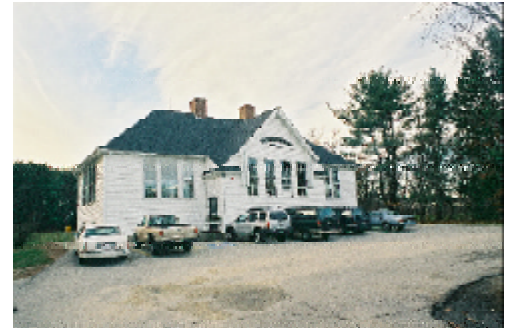
Originally one of the Town's first elementary schools, it was constructed in 1896 and is approximately 5,000 sf. in area (including the garage). Building plans were not available for this building and building measurements were not taken, thus this figure is an approximate figure. The building has had a number of various occupants including the Police department and adult education classrooms. The building now houses the school district offices.
