ARCHITECTURAL ASSESSMENT

Hanover High School

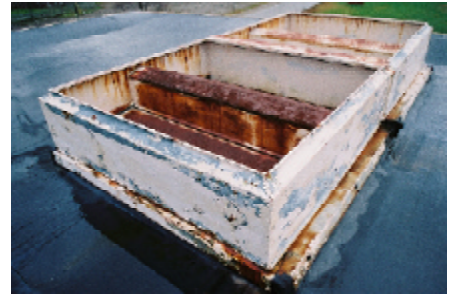
- c. The expansion joint between the 1958 building and 1964 addition, constructed of wood, does not appear to be per industry standards and had a notable deflection. In addition, the rubber roofing at this location had a large gouge that exposed the wood. Leaks were reported at this location
- d. The roof was leaking at the time of our visit at the roof access hatch.
- e. Ponding water noted in several areas; additional roof drains are recommended.
- f. Roof appeared to be spongy in some areas. Further investigation is warranted.
- g. Smoke vents at stage are severely rusted.
- h. Areas of the roof membrane were not ballasted appropriately. It appeared that when repair work had been done recently, the stones were not placed back to their original location. This may result in wind uplift issues.

5. Replace entire roof system and fascia, except for recently installed fully adhered membrane system. Utilize tapered insulation. Install additional roof drains.
6. Replace stage smoke vents.

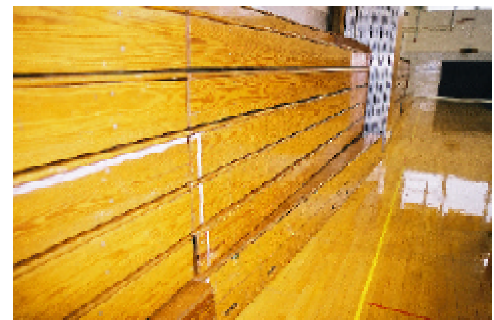
1. One science lab had been recently upgraded with new equipment, while others are still utilizing original tables and casework. The original tables and casework are over 40 years old, have been gouged and damaged and should be replaced.

2. Woodshop equipment is mostly original. These require maintenance on a regular basis and parts are difficult to find. Recommend replacement.
3. Bleachers are original, wood construction and are in fair to good condition. Parts are difficult to find, maintenance and upkeep is frequent. In addition, they are not handicap accessible. Recommend replacement.

4. Most library furnishings have been recently upgraded.
5. Auditorium seating is original, of metal and wood construction, most are in good to fair condition, while some are damaged and unusable. Recommend that all seating be replaced.

6. Numerous pieces of kitchen equipment are in need of replacement; all are original and require frequent maintenance and upkeep. Cooler and Freezer compressors are noisy, located in the kitchen, and should be on the roof instead.

Generally speaking, once furnishings reach a certain deteriorated state, they are no longer treated well by the students and rapidly become unserviceable. We recommend that an inventory of existing equipment be conducted to evaluate which furnishings could be repaired and re-used and which should be replaced. The bleachers should be checked for safety by a qualified inspector for the short term and replace with new for the long term.

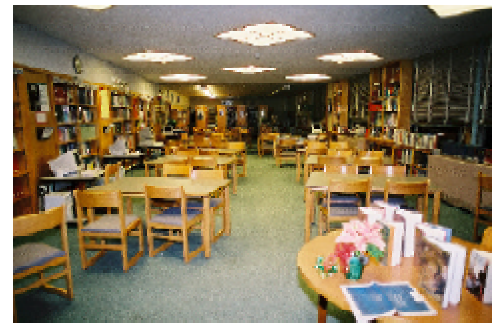
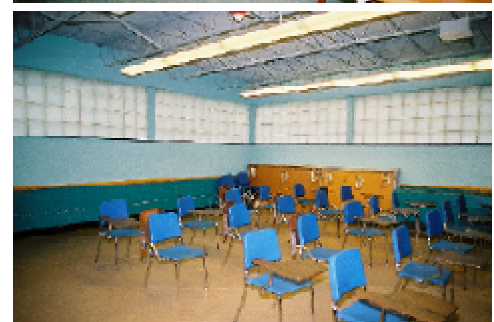
- 1. Although the Library has increased in size by engulfing classroom space, some original library space has been lost to other school use. The resulting long, narrow configuration is not ideally suited for the function and use of a high school library and media center. The size of the library appears to be below state minimum guidelines.
- 2. Library has inadequate space for audio/visual storage. The original a/v room is now a computer/math room.
- 3. Home Arts is now a teachers room.
- 4. Guidance is housed in what previously was a classroom.

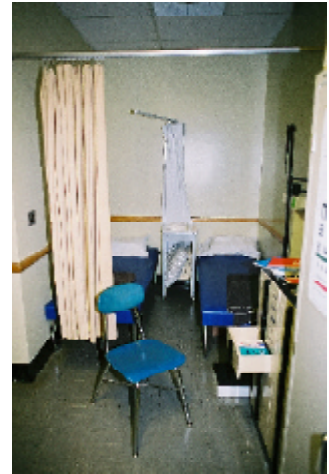
5. The student council storage room was previously a toilet room.
6. The shop program has been gaining more popularity in the area of technical drawing, industrial and visual arts, requiring more space.
7. There is a lack of storage space for general use and classroom use.
8. One classroom has been converted to be a learning resource/tutorial room for small group instruction and one-on-one assistance.
9. Nurse's room is very small and offers almost no privacy for exams and personal discussion with the nurse.
10. No space for Choral students. The stage is used as a classroom space.
11. Auditorium stage wings are small; inadequate space for storage or sets.

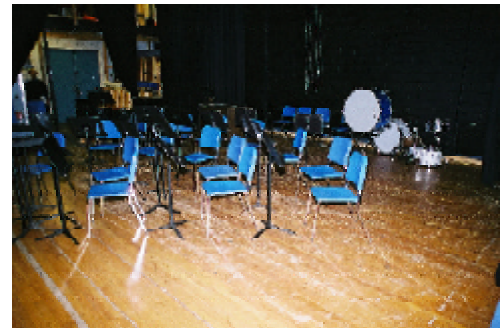
12. No music practice rooms as they are now used for storage.
13. The kitchen dishwashing area is located directly in the middle of the kitchen; this results in an inefficient/less than ideal work area for food preparation and food serving.
14. Kitchen dry storage space and freezer storage space is limited.
