## **ARCHITECTURAL ASSESSMENT**

### **Salmond School**

Originally constructed in 1931, the building has not had any additions and very few upgrades and interior modifications. The building is approximately 13,500 sf in area. The building currently does not serve as a school but is being used as a temporary home for the public library. As such, some educational use issues could not be addressed during this assessment.

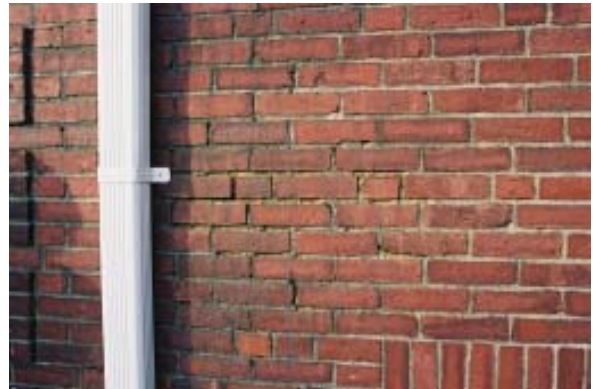
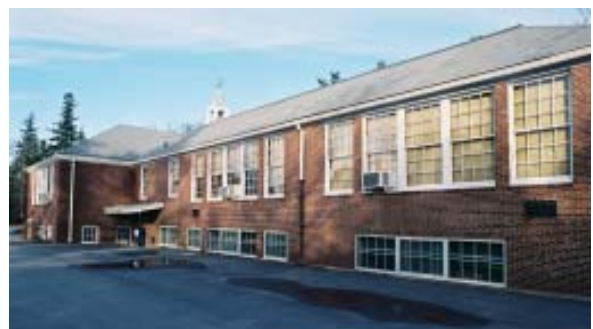
The building is in overall good condition with no apparent structural concerns. General items of concern are as follows:

1. The brick appeared to be in generally good condition considering the age. Some locations around the building exhibited deterioration of the joints, mold and mildew. Minor brick repair, re-pointing and cleaning is recommended to prevent further deterioration.

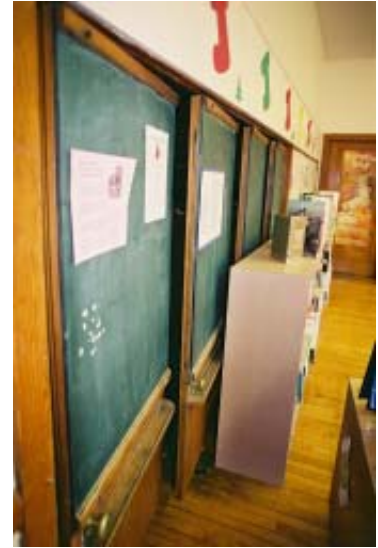
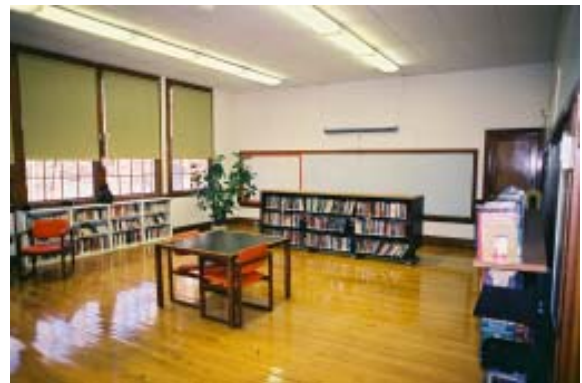
1. The school does not have a gym, art, music, kitchen, cafeteria, or library space. It did have a platform that may have been used for small plays or school assemblies, but a wall has been constructed where the opening was previously and an office now occupies this space. There is some indication of a kitchen in the basement floor plan, but access to this space was not possible at the time of the site visit.
2. The size of the rooms appeared to be small according to state standards for an elementary school.
3. Lack of classroom storage space.
