## ARCHITECTURAL ASSESSMENT Sylvester Elementary School

Originally constructed in 1927 with an addition in 1960, the building has an area of approximately 33,210 sf. and currently houses 235 students. General facility comments are as follows:

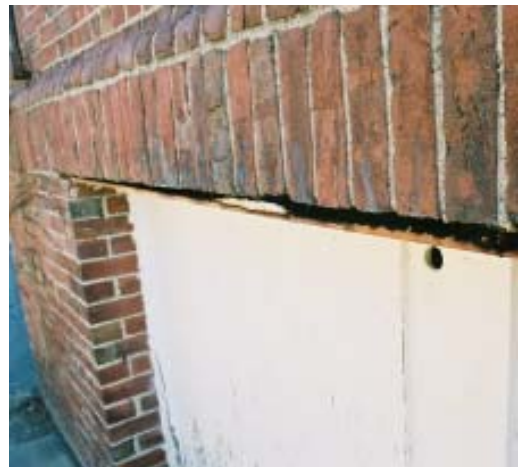
The exterior of the building is generally in very good condition with the exception of:

- a. The deteriorating single-pane wood windows (source of extreme heat loss). Chipping and peeling paint is most likely lead-containing paint and should be removed. Recommend full replacement.
- b. Concrete steps are in poor condition; appear to have been repaired a number of times. Recommend full replacement with accessible ramp.
- c. Deteriorated and discolored brick on the exterior of cafeteria due to years of ivy growth. Some brick cleaning and repointing is recommended.
- d. Rusted and failing steel lintels at cafeteria windows. Excessive water infiltrating the steel over time has caused the steel to expand and corrode. Lintels

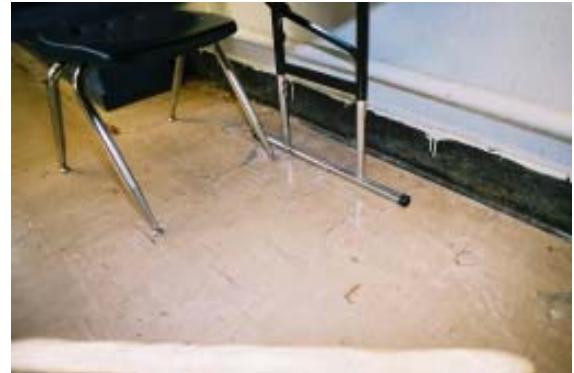
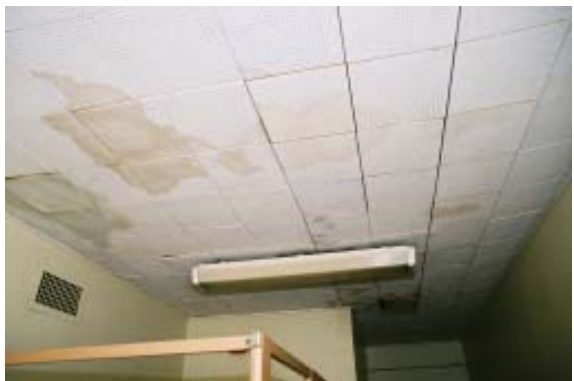
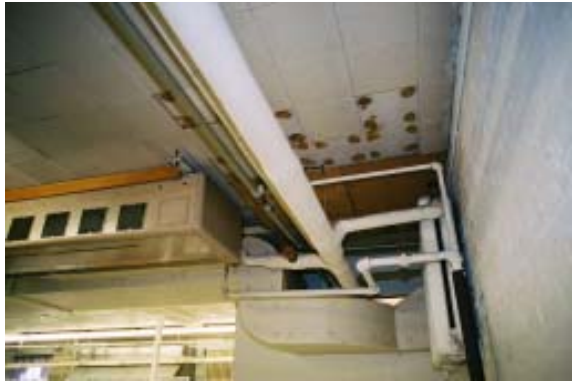
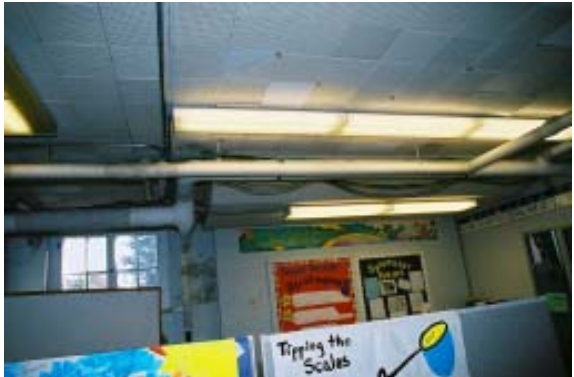
Floors are mostly wood construction with Vinyl Asbestos Tile (VAT) and original wood planks. VAT is in fair condition with some areas tile has broken. Wood floor is uneven in some areas causing a potential tripping hazard, while in other classrooms it is remarkably still in very good condition.

Leaks occur in the basement between floor and wall.

Ceilings throughout are mostly glue-on ceiling tile with suspended acoustical ceiling panels in the 1960 addition and some plaster ceilings in the basement. The glue-on ceiling tiles are a continual problem for maintenance staff as they become loose and fall easily. Many tiles are stained due to building leaks.

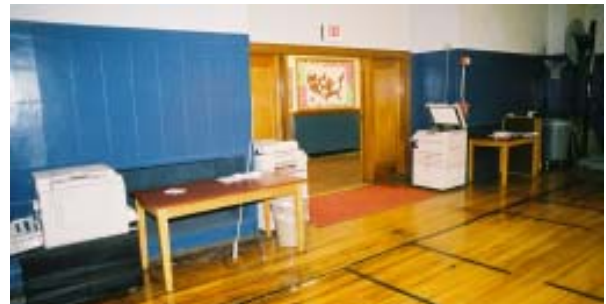
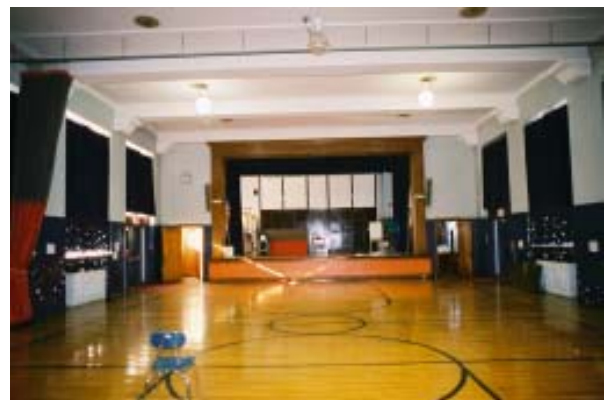
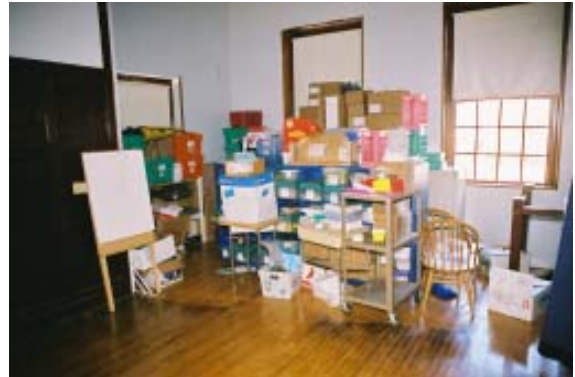
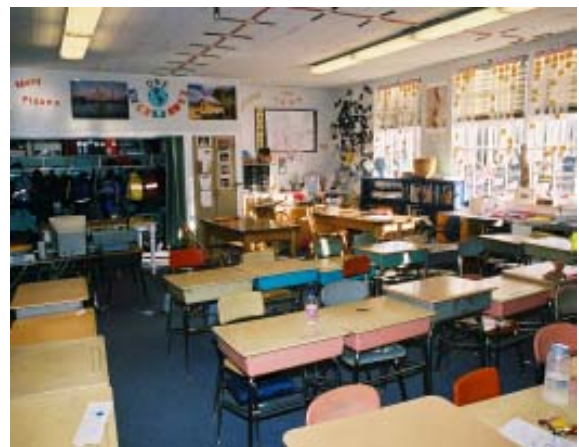
1. The school does not have adequate space for Art, Music and Gym programs, thus the students must walk to nearby Center Elementary School for these programs.
2. Lack of classroom and general storage space
3. Lack of space for backpacks/cubby units.
4. Nurse's office is very small and offers no privacy for students.
5. Lack of conference space
6. Lack of administrative work space. Copiers and work tables are currently located in the gym/auditorium.

7. Gym is heavily used by community: HS cheerleaders, adult night school, aerobics, Destination Imagination, Odyssey of the Mind, Student Council, local meetings, parent gathering. The community enjoys coming to the school.
8. The stage is used for storage of art supplies and other school supplies.
9. Many classrooms are undersized to meet current needs and programs. Aisle space does not meet current code.

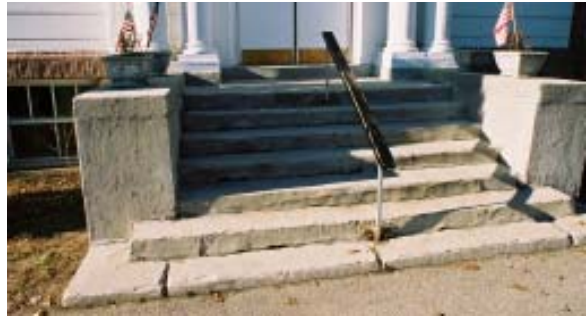
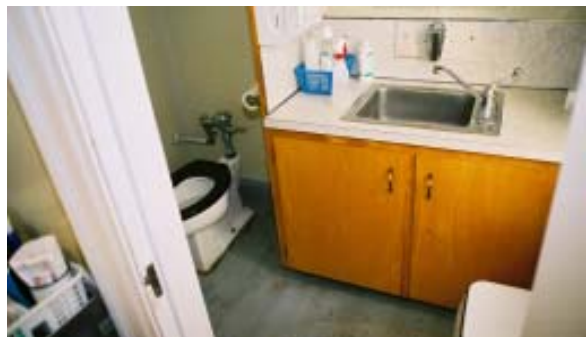
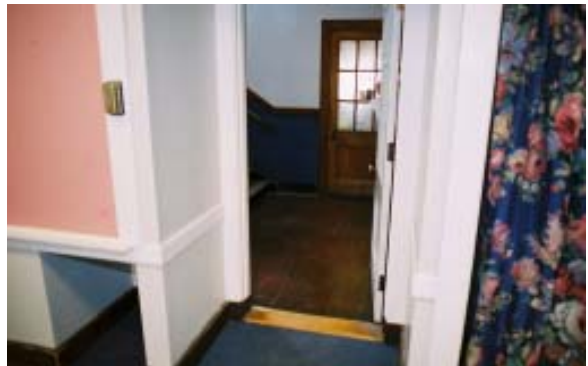
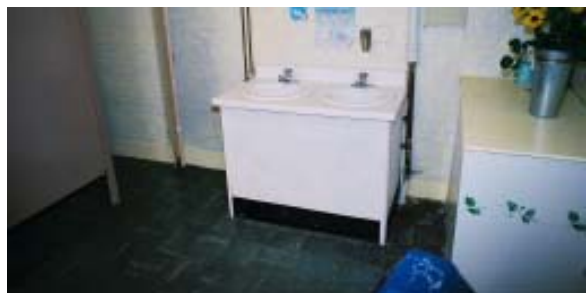
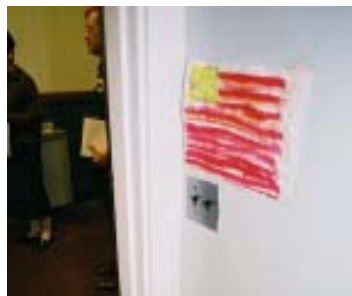
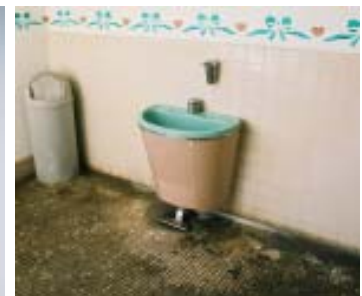
1. Stairs at each entrance into the building
2. Basement, first and second floor are not accessible. No elevator or lift to access each of the floors.
3. Stage not accessible.
4. No lever hardware at doors
5. Lack of proper room signage
6. Double door leafs are too narrow.
7. Clear space adjacent to latch side of doors.
8. Sinks in classrooms.
9. Toilet rooms throughout the building are not accessible, including the nurse's room. The following items are not in compliance:
  - a. Lavatories
  - b. Toilets and urinals
  - c. Grab bars
  - d. Door width and clear space adjacent to doors
  - e. Clear turning space at single fixture toilet rooms

Although it appears as though some building features are accessible to the disabled, many unfortunately are not. Each of the inaccessible features listed above has an impact on the ability of disabled students or

members of the community to access various spaces throughout the school independently. Disabled people may include students with a permanent handicap condition, students that are temporarily disabled from athletic activity, parents or other visitors that could have any form of disability. Any form of renovation plan should incorporate as many items as possible to accommodate disabled people to the fullest extent possible.
